MEMORANDUM INTERMOUNTAIN POWER SERVICE CORPORATION INTERMOUNTAIN GENERATING STATION

SUBJECT: Follow up report regarding Cooling Tower Fan Blade

Resonance

SUBJECT: Follow up Report Concerning the Cooling Tower Fan Blade
Resonance and Ceramic Cooling Towers Proposed use of a Ten Blade Fan System

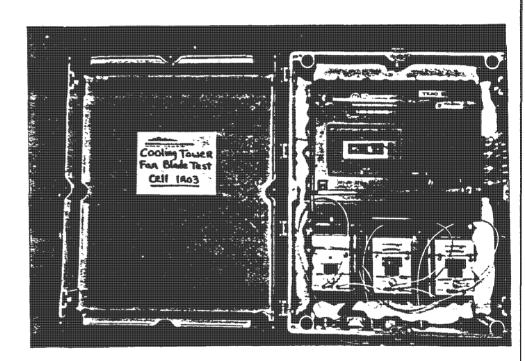
PICTURE # 1

Fan cell 1A03 was selected for this special vibration test because of several tripping problems due to a blade droop switch being activated. Acceleration probes were mounted at the end of three of the seven blades, (see picture #1). A cable was then run from the probe to a recorder and power system, which were mounted in the center of the fan hub, (see pictures 2 thur 5). A key phaser was also attached to the fan hub and referenced to a point on the gear reducer. With this unique setup, vibration data concerning the blade movement could be obtained while the fan was in operation.

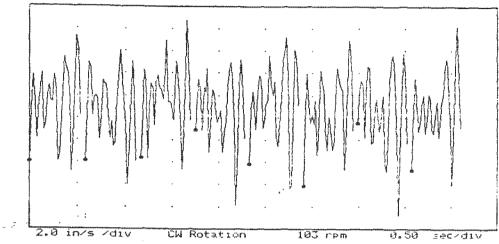
Machine: Cooling Tower Fan 16 OCT 87 08:20:49.8 Steady State CH# 1 Blade # 1

The data gathered first was the result of a fan static condition, while air was short circuited through the dormant cell. As attachment 1 indicates the three blades were being excited at natural blade resonance, 412 cpm. Attachment two indicates the signal waveform of the three blades as the fan was in operation. The waveforms have been integrated from acceleration to velocity with the ADRE 3 Data Acquisition System. All values indicated in these plots should be multiplied by a factor of 10. Attachment 2 indicates very clearly that each blade was being excited four times during each revolution. Other minor spikes in the waveform indicate reaction to other blades moving in the fan system, thus creating a fan hub wobble. Signature traces, cascade plots, and careful attention to the key phase reference mark in attachments 3 - 6, bear this last comment out. The probe on blade # 5 was damaged shortly into the test, so data was not available.
